The Chimney Guy, Inc.

Inspection Report

Client: Michael Bell
1550 Loma Vista St.
Pasadena, 91104
(626)354-8505
mike@michaelbell.com

On December 22, 2025, one chimney was inspected at the above-mentioned address.

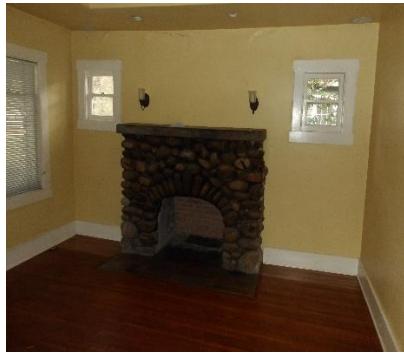
Living Room Fireplace (Masonry)

There is no mesh screen in the front of this firebox opening. A mesh screen is required to prevent hot embers and sparks from escaping through the top of the firebox opening. One can consult with a contractor about this issue. (FBO-36x28 1/2")

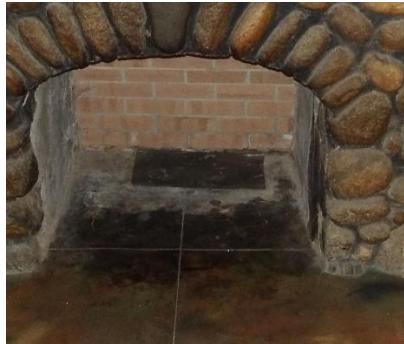
There are gaps in the surfaces of the firebox of this fireplace, and cracks in the surfaces of the firebox floor. This is a potential fire hazard with the chance for heat to pass through the opening and reach the wood structure. ***I recommend removing the loose pieces, resurfacing the firebox floor, and sealing the gaps in the firebox with a hi-temp mortar as needed.***

There is no grate in the firebox. A grate is needed to sit the material for the fire upon. ***I recommend placing a new grate in the firebox. (24" in size.)***

There is no ash dump door towards the back of the firebox on the floor. This is a potential fire hazard with the chance for hot embers and coals to fall below and the heat from the embers to reach the wood structure within the radius of the ashpit. ***I recommend installing a new ash dump door in the firebox as needed.***

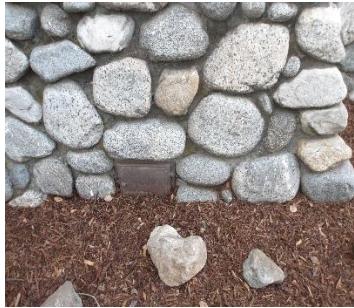
The ash cleanout door located on the exterior of the chimney is damaged by rust. This is a potential fire hazard with the chance for hot embers and sparks to exit through the openings. ***I recommend installing a new ash cleanout door on the exterior of the chimney and sealing around the connection as needed.***

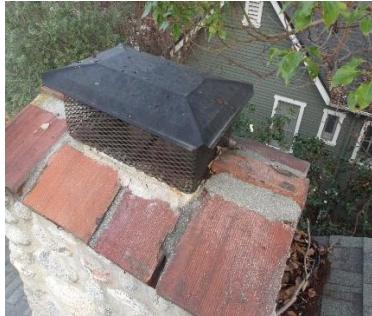
There is a spark arrester/ cap assembly at the top of the chimney. A spark arrester/cap assembly is needed to prevent the exit of hot embers and sparks through the top of the flue, and to prevent the entrance of water and small animals through the top of the flue, and is required to have a removable cap. ***I recommend installing a new spark arrester/cap assembly with a new top damper to the top of this chimney. (13x20" in size.)***

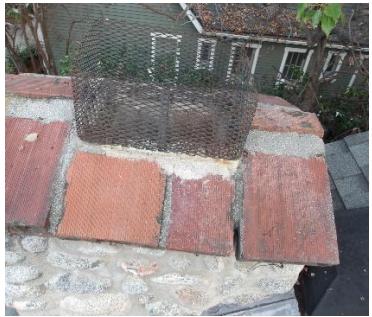
The crown area of this chimney is not completely covered with mortar, and there are openings in the cement block bricks that are installed at the top of the chimney as part of the crown for decoration. This is a potential hazard with the chance for water to enter the structure of the chimney and reach the iron that is installed in the walls for structural reinforcement, which can cause the iron to expand, pushing the bricks (cement) out of place, resulting in exterior cracks. ***I recommend constructing a new crown with fresh mortar and sealing the openings seen with mortar as needed.***

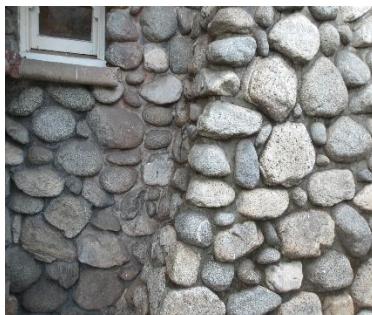
There are gaps in the exterior surfaces of the chimney in various areas. This is a potential hazard with the chance for water to enter the structure of the chimney and reach the iron that is installed in the walls for structural reinforcement, which can cause the iron to expand, pushing the bricks (cement) out of place, resulting in exterior cracks. There are also cracks seen on the cement mantle above the fireplace. One can consult with a contractor or handyman to address this issue.

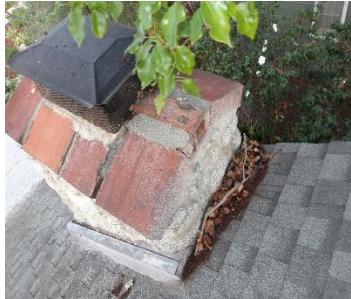
The chimney at the top above the roof is short of the required height. It is required for a chimney top to be at least 36" above the roof and 2' above anything within 10' of the top of the chimney. ***I recommend installing an extension at the top of this chimney to bring this chimney top up to the required height. (36" high extension)***

There are trees within the radius of the top of this chimney. It is required for there to be at least a 10' clearance from combustibles around the top of a masonry chimney that is being used to burn wood. One can consult with a contractor to address this issue.

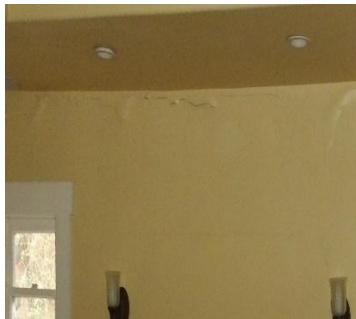
There are signs of possible water intrusion seen in the surfaces of the ceiling area across the top of the wall surfaces above the fireplace. This is a sign that there are some possible issues with the flashing installed around the chimney on the exterior of the house. One can consult with a roofer about this issue.
