WOOD DESTROYING PESTS AND ORGANISMS INSPECTION REPORT

| Building Address: 3282 Beaudry Terrace, Glendale, CA 91208 | | Date of Inspection 04/21/2026 | Number of Pages 7 |
| <p>Del Rio Termite & Pest Control 1508 Highland Ave. Duarte, CA 91010 Phone: (626) 930-8722 Fax: (626) 930-8723</p> | LEAD-SAFE EPA CERTIFIED FIRM NAT-84206-1 | | Report # W37559 |

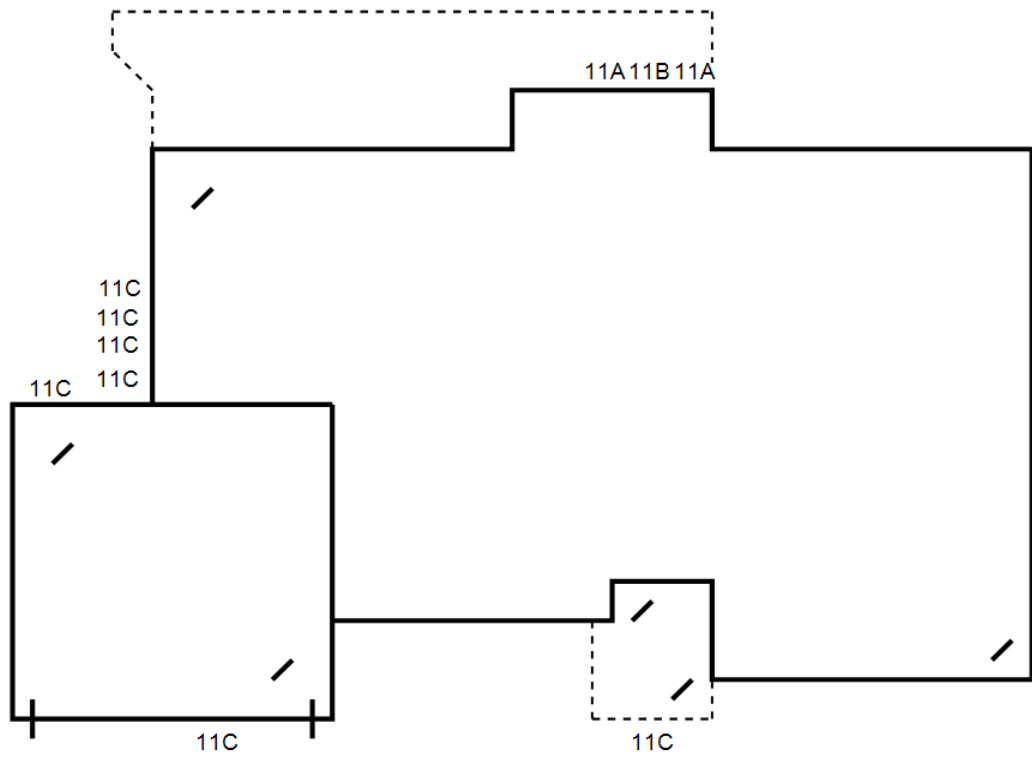
- 11A PRICE: \$280.00 (Section I)
FINDINGS: Evidence of drywood termite infestations at exterior.
RECOMMENDATION: Chemically treat visible and accessible infestations. Liquid solutions may be applied in the form of mist spray to exposed framing. Liquid solution may also be injected into termites galleries where infestations are accessible. Remove or cover all accessible pellets and frass of wood-destroying pests. NOTE: LOCAL TREATMENT IS NOT INTENDED TO BE AN ENTIRE STRUCTURE TREATMENT METHOD. IF INFESTATIONS OF WOOD DESTROYING PESTS EXTEND OR EXIST BEYOND THE AREA (S) OF LOCAL TREATMENT THEY MAY NOT BE EXTERMINATED. ONE YEAR LIMITED GUARANTEE ON ALL TREATMENTS DONE BY THIS COMPANY. * NOTE: HOUSE PREVENTIVE TREATMENTS ARE AVAILABLE UPON REQUEST AND CONSIDERED A SECTION 2 ITEM.

- 11B PRICE: See 11A (Section I)
FINDINGS: Evidence of termite damaged wood members noted at time of inspection.
RECOMMENDATION: Replace/Repair damaged wood members as necessary. Del Rio Pest Control is not responsible for any damage to roofing materials that may occur during repairs made to roof eave members. If additional adverse conditions are uncovered during repairs, further inspection will be recommended and a supplemental report will be issued indicating any infection, or additional repairs. Painting is included.

- 11C PRICE: \$480.00 (Section I)
FINDINGS: Dry-rot wood members found at time of inspection at exterior eaves, fascia board and rafter ends as indicated on diagram
RECOMMENDATION: Replace/Repair dry-rot damaged wood members as necessary. Del Rio Pest Control is not responsible for any damage to roofing materials that may occur during repairs made to roof eave members. If additional adverse conditions are uncovered during repairs, further inspection will be recommended and a supplemental report will be issued indicating any infection, or additional repairs. Painting is included.
